# Cascadia Contractor Hazard Alert

Date of Incident: December 27, 2005

Unit: Stillwater Timberlands

## Incident: Helicopter pilot struck by rotor blade

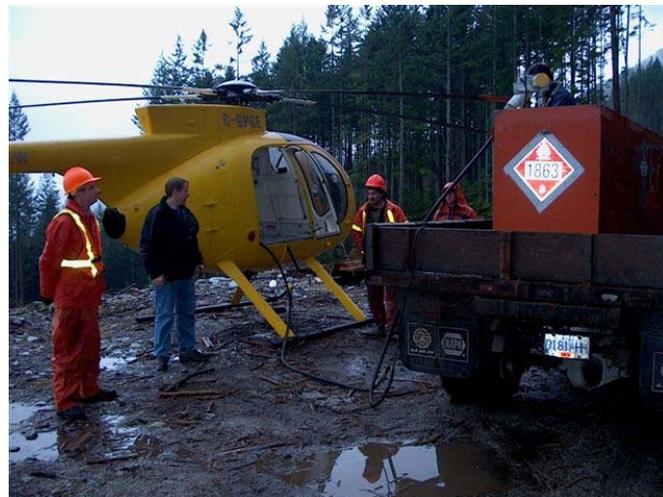
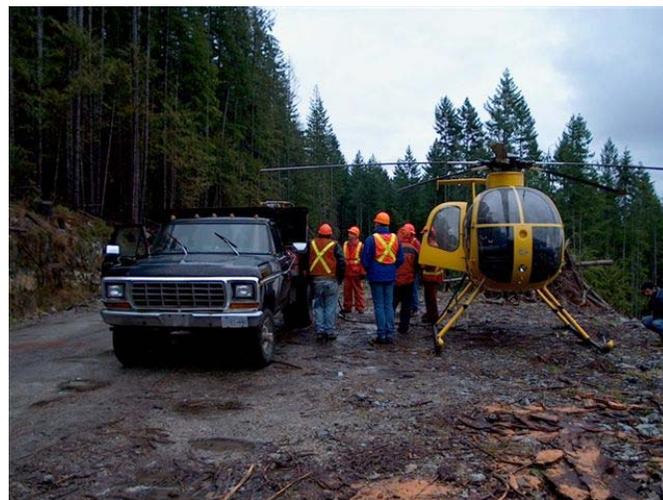
After landing for the third refueling of the day, the pilot positioned one of the skids of the helicopter 7' from the edge of the flat deck. This in turn, positioned the main rotors to extend 2'3" over top of the flat deck. The pilot shut down the helicopter, knowing the fuel pump had to be moved from one drum to the other. He exited the helicopter and went around to the back of the flat deck and started to have a conversation with one of the shake cutters while the rotor blades were coming to a stop. The pilot then proceeded to climb onto the flat deck to change the fuel pump to a new drum, while the shake cutter proceeded towards the other pickup truck. As the pilot pulled himself onto the flat deck and proceeded to stand up, he was struck on the right side of his head by one of the revolving rotor blades. The shake cutter heard a bang and turned and saw the pilot lying on the floor of the flat deck. He rushed over and comforted the pilot while summoning first aid. The pilot was then transported by ambulance to Powell River Hospital before being flown to Lions Gate Hospital in Vancouver with serious head injuries.

1. Fuel tank position and helicopter landing area were in too close proximity to each other.
2. Pilot climbed up onto flat bed with rotors still turning.

1. Perform a pre-planning exercise including a risk assessment before starting task.
2. Develop a written SOP for refueling that includes safe clearances, location of fuel barrels, etc.
3. Always remain totally focused on the task at hand, especially when the consequences may result in serious injury or death.
