Mechanical failure of rock truck results in fatal runaway

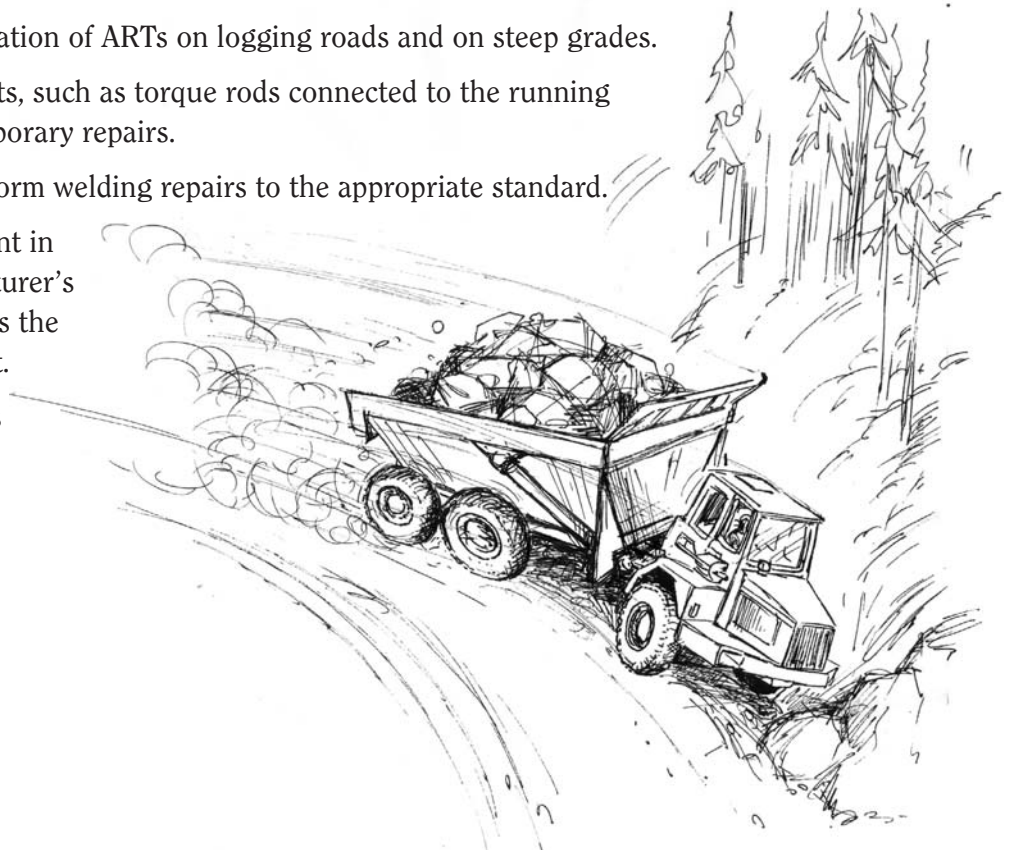
A young worker was operating an articulating rock truck (ART) that was end hauling rock from a blast site. While the truck was travelling down a newly constructed steep logging road (23 percent), the brakes failed. To slow the truck down, the operator drove it into a ditch. The ART tipped onto its box and slid down the ditch line until the cab struck a large rock outcrop. The driver was ejected and was struck by a large rock that was thrown from the truck's load. He received fatal injuries.

The investigation found that a rear-axle torque rod had broken away from the housing at an improperly welded repair. Excessive movement of the box may have cut the rear brake line and air line. The front brakes and the partial use of the centre-axle brakes were not able to stop the truck as it gained speed on the steep hill.

- Train drivers on the safe operation of ARTs on logging roads and on steep grades.
- Replace defective integral parts, such as torque rods connected to the running gear, rather than making temporary repairs.
- Use a qualified person to perform welding repairs to the appropriate standard.
- Repair and maintain equipment in accordance with the manufacturer's instructions and any standards the equipment is required to meet.
- Ensure the required seat belts are provided and are worn by operators.
