Safety Alert

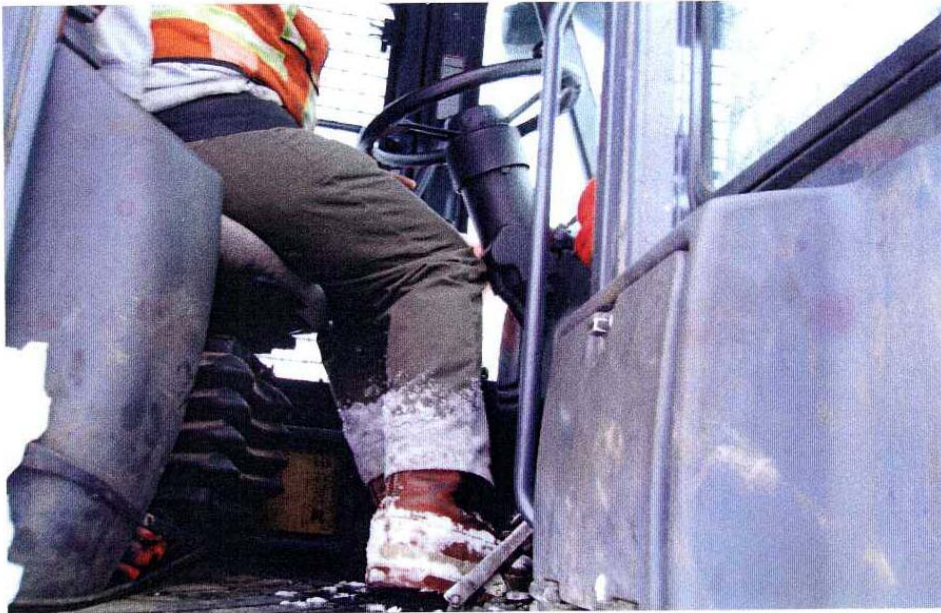
Recently a contractor's employee who operates a grapple skidder suffered an injury when his knee hit the steering column. In this incident the operator was driving the skidder while he was twisted to the left in his seat so he could look out the left side of the machine to observe some branches & tree tops he was maneuvering around. In positioning himself this way, the operator's right knee was located in very close proximity to the steering column. In the course of this activity, the skidder blade hit an obstacle jolting the skidder to a sudden stop. The operators knee was then jammed into the steering column causing injury to his knee and hip.

A review of the positioning of the operators knee in proximity to the steering column indicated a space of 5-10 cm only between the knee and the steering column when the operator is positioned with some "twist" in the seat. The seat belt did not prevent the knee from contacting the steering column given the little space in between.

We recommend that contractors assess their skidders and consider affixing some (foam) padding to the steering column along the portion that is at risk of sudden contact with knees & legs. This padding will provide cushioning in the event of unexpected sudden impacts.
